ACCIDENT

REPORT

Reference A-12 Accident Report

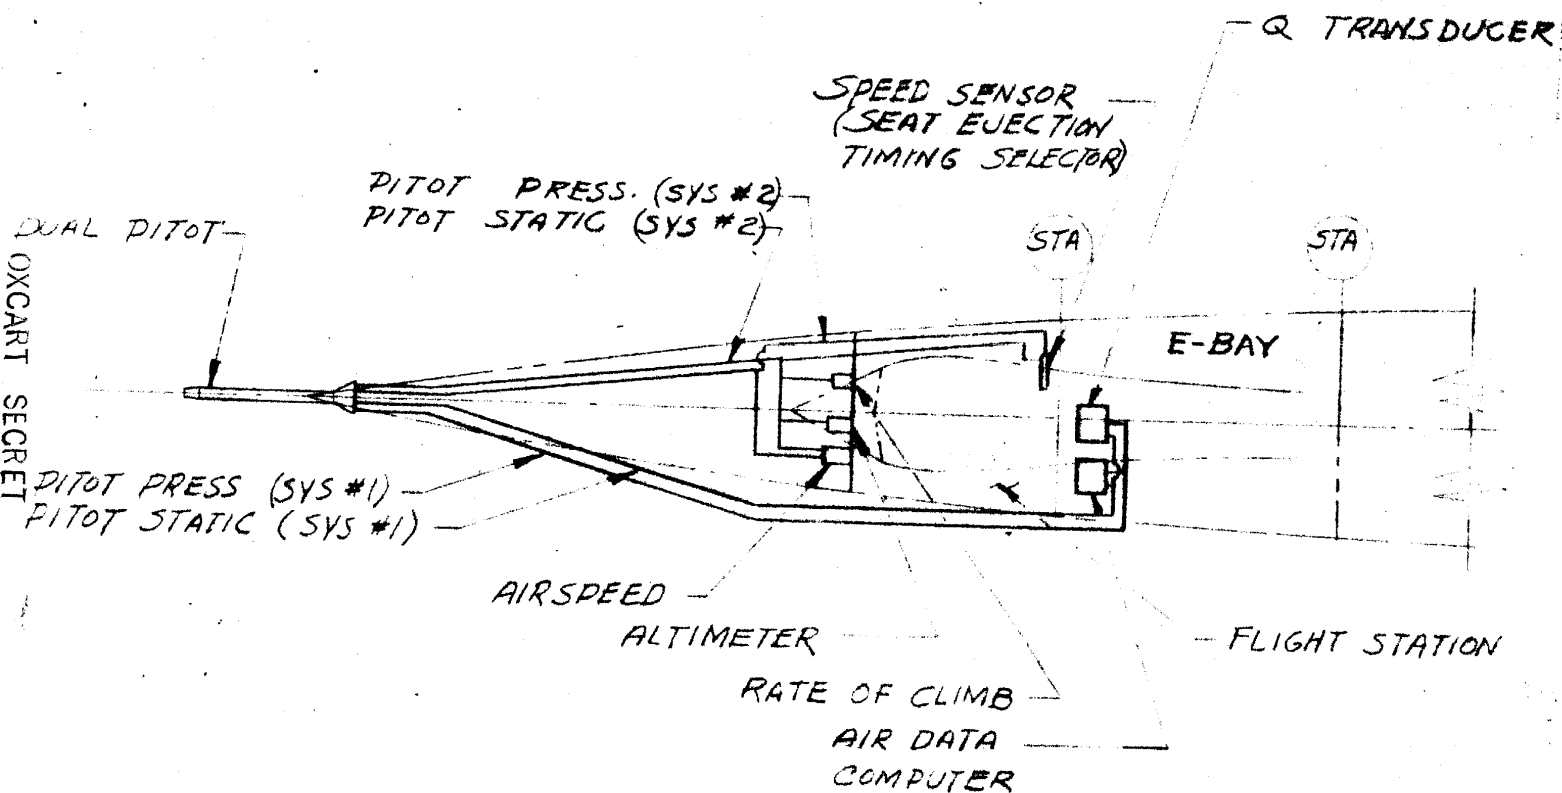
PITOT-STATIC SYSTEM CALIBRATION
KOLLMAN PITOT STATIC TYPE NO. A35530 00 003

1. Primary Cause: The primary cause of this accident was materiel failure in that the total pressure ports of the pitot system probably became blocked by ice, which gave the pilot false increased airspeed and Mach readings on both the TDI and conventional indicated airspeed system, this was followed by unplugging which caused rapid rundown of Mach and KEAS back to correct readings at approximately 160 KEAS, further confusing the pilot.

b. A study to determine the feasibility of the installation of an alternate pitot source and a cockpit warning device to indicate pitot heat failure should be accomplished as soon as possible. If this study indicates the practicability of these installations they should be accomplished prior to release from VFR restrictions.

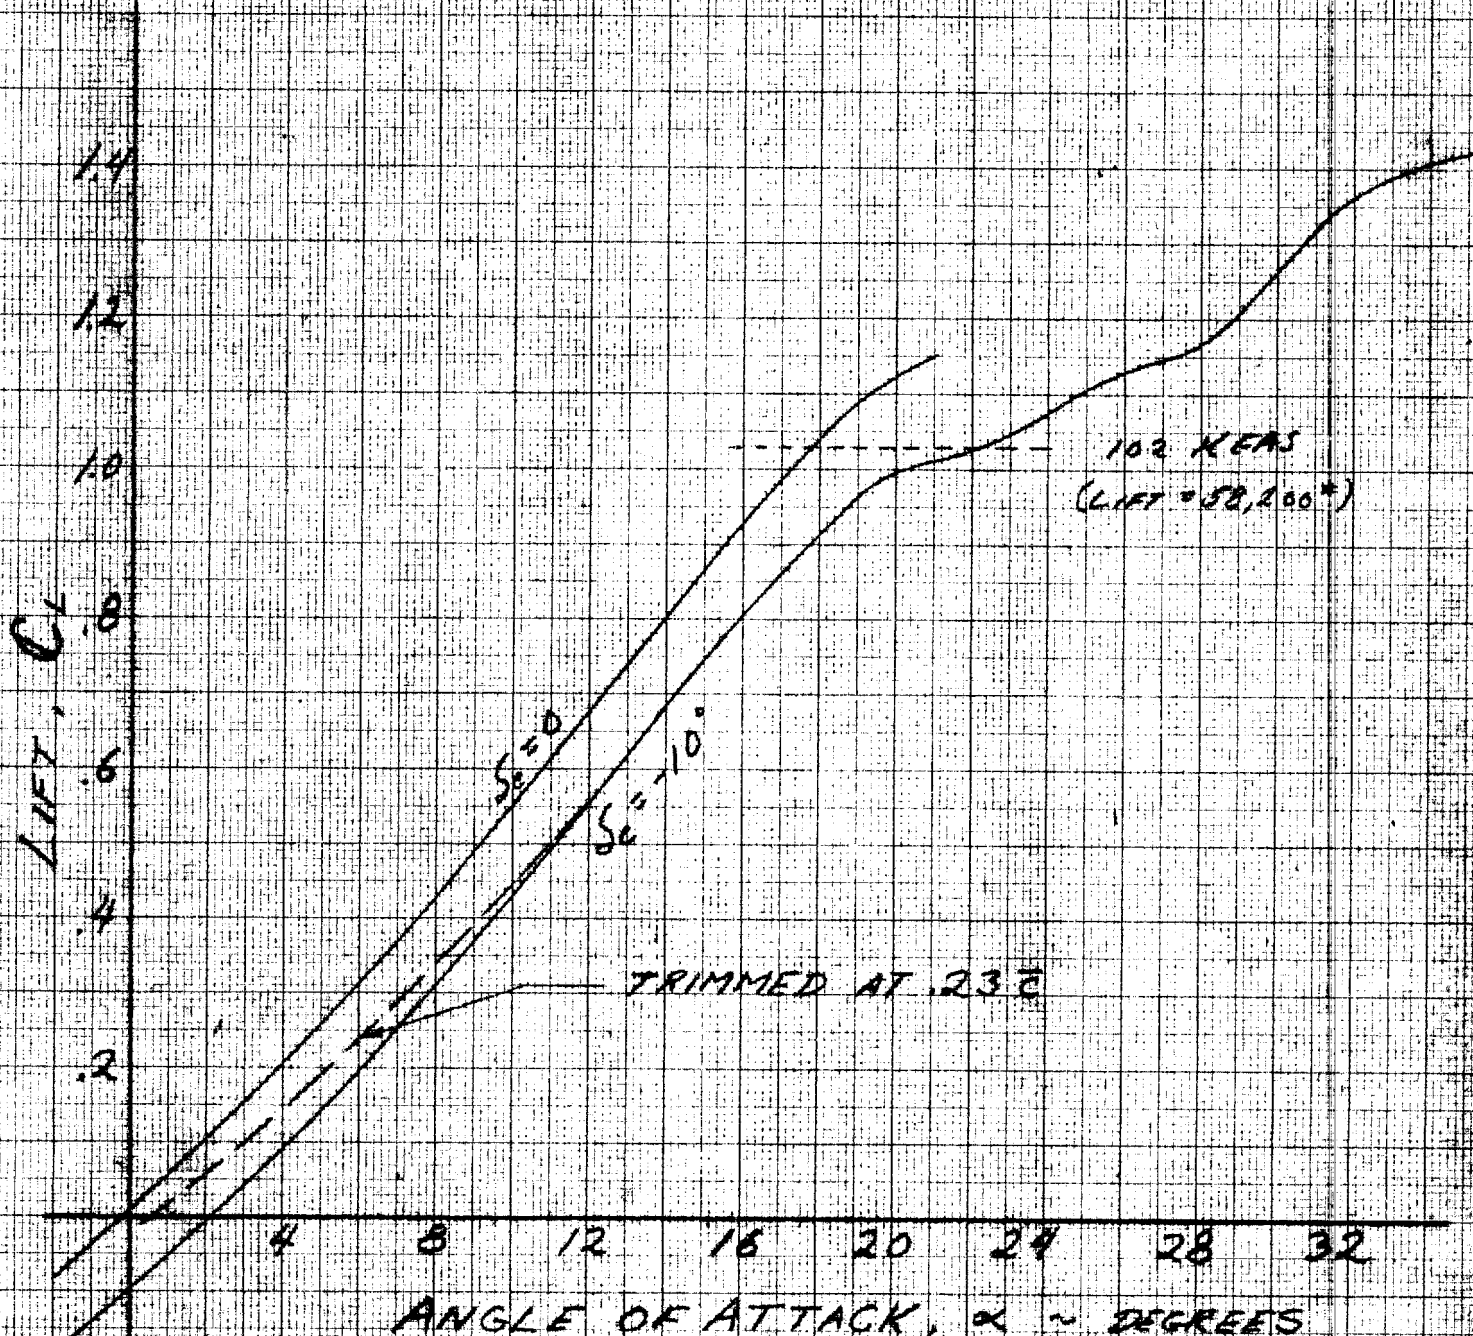
a. The elevon trim actuator was found extended to a position of 5° nose down and the elevons were found in this position at impact.

A preliminary investigation indicates that the elevons were trimmed to +5 degrees at impact, which is a hardover nose down trim position. This trim position is an incremental +10 degrees from the required trim position at the last reported speed just prior to the stall and inverted spin. Thus, if this trim position actually existed prior to the stall, there existed a pitching moment equivalent to +10 degrees elevator, which would have tried to nose the aircraft over into a -.5 "g" pushover. A pushover of this magnitude would develop a descent angle at the rate of 10 degrees a second at 101 KEAS at 30,000 feet. A descent angle of 10 degrees, combined with Military power and the drag at -0.5 "g", would have resulted in an acceleration even at 101 KEAS. It can, therefore, be concluded that the trim actuator input was being counteracted by pilot input. The above conclusion is further substantiated by the fact that the autopilot, when in the Auto-Nav mode, utilizes an attitude hold mode in the pitch axis; thus, the autopilot would be putting in nose down elevon to oppose the buildup in angle of attack due to the deceleration. When the autopilot is disengaged with the CSC button, the Mach Box would continue to put nose down elevon in with decreasing speed. In terms of stick force, the pilot effort required to counteract the trim actuator input is approximately 20 pounds.
